UNITED STATES  
NUCLEAR REGULATORY COMMISSION  
OFFICE OF NUCLEAR MATERIAL  
SAFETY AND SAFEGUARDS  
WASHINGTON, DC 20555-0001

April 16, 2013

NRC INFORMATION NOTICE 2013-07:     PREMATURE DEGRADATION OF SPENT FUEL  
  STORAGE CASK STRUCTURES AND  
  COMPONENTS FROM ENVIRONMENTAL  
  MOISTURE

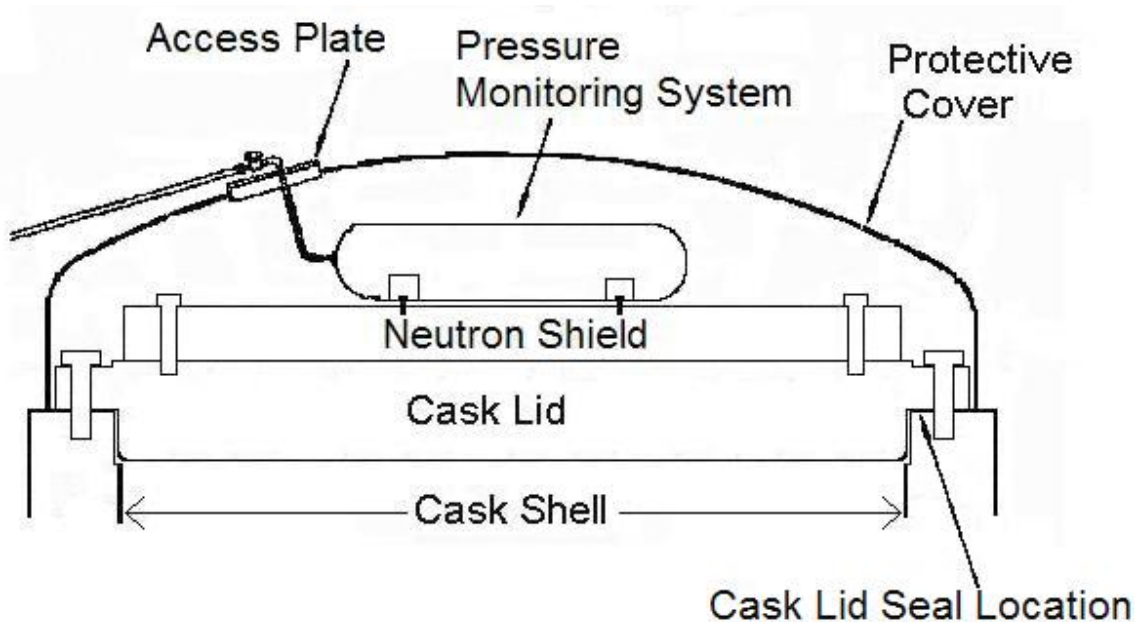
Figure 1

spent fuel assemblies to the spent fuel pool to perform additional inspections on the cask lid and seals. The initial evaluation revealed corrosion of the outer portion of the cask lid seal, lower than expected torque on some of the main lid bolts, and corrosion on the threads of the lid bolts. The inner portion of the cask lid seal remained intact; therefore, the cask's primary confinement was not compromised.

A root cause evaluation concluded that the seal leakage was caused by corrosion of the outer portion of the cask lid seal from water infiltration through the access plate in the protective cover. The water infiltration caused galvanic corrosion of the outer portion of the cask lid seal due to the presence of moisture at the interface of the aluminum-clad cask lid seal and the stainless steel clad cask body sealing surface. The presence of the moisture at the interface of the two dissimilar metals set up a galvanic cell that caused the aluminum to corrode and allowed helium to leak through the outer portion of the cask lid seal. The root cause evaluation further stated that the helium leak was attributed to inadequate sealing of the access plate in the protective cover and a lack of any verification of the integrity of the water-tight cover. The primary corrective actions developed by the cask vendor and the licensee involved improving the access plate design and developing a method for verifying protective cover seal integrity. Additional corrective actions, which were incorporated into operating procedures immediately after the event, included a change to the lid bolt torquing process and ensuring access plate gaskets and O-rings were inspected at installation.
