**SUBJECT: THREE MILE ISLAND STATION, UNIT 1 – NRC INTEGRATED
INSPECTION REPORT 05000289/2014004**

Enclosure: Inspection Report 05000289/2014004
w/Attachment: Supplemental Information

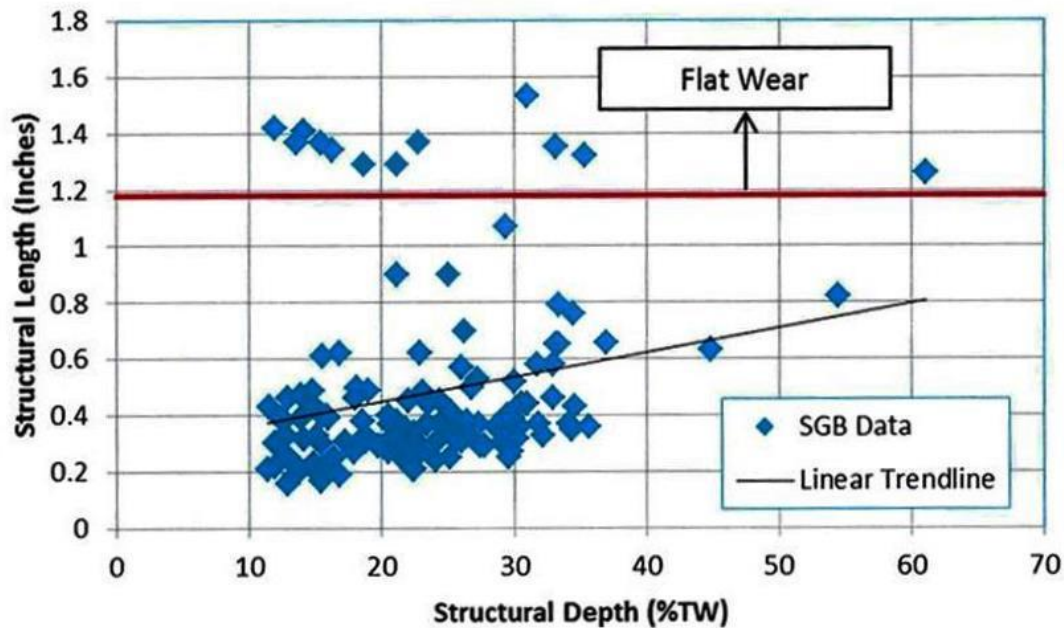
Figure 1: All Profile Results for SGB

As shown in Figure 1, there is some correlation between structural length and structural depth. However, as previously mentioned, this correlation is primarily driven by the shallow, tapered indications. When a tapered flaw first initiates, it will only be present at one edge of the support and may only have a total length of 0.4", for example. Obviously, if the total length is 0.4" and the flaw is tapered, its structural length will be less than 0.4". As the flaw grows in depth, its total length and structural length will increase provided the taper angle remains the same. This is the primary reason that there is an apparent relationship between structural length and depth.

In order to illustrate the effect that the shallow tapered indications have on this correlation, another curve was generated which includes only those profiled indications with total measured lengths greater than 1 inch. Applying this criterion effectively eliminates the shallow tapered indications since tapered flaws would need to grow to a relatively deep depth before they would reach a length of 1 inch. This relationship is shown in **Figure 2** as shown in the figure; there is no correlation of increasing structural length with increasing structural depth. Hence, for the flaws of most concern (flat or tapered and relatively deep), there is no correlation between structural length and structural depth.
