The NRC and Nuclear Power Plant Safety in 2011

LIVING ON BORROWED TIME

DAVID LOCHBAUM

March 2012

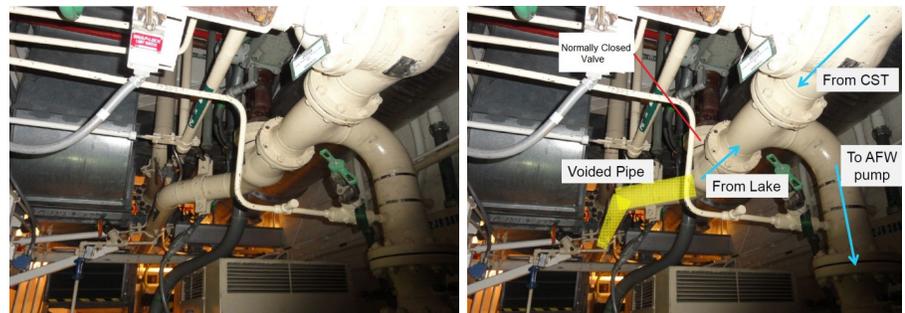
At Byron and Braidwood, this piping supplies water to auxiliary feedwater pumps needed during emergencies to prevent heat from damaging the reactor core. (The two photos are identical, except for the labels on the right-hand photo.) The yellow shading highlights piping drawing water from a nearby lake—the focus of an NRC special inspection.

The longstanding practice at Byron and Braidwood was to keep the pipes from the lake emptied of water, to prevent any untreated lake water from leaking past a closed valve and entering the steam generators, where it could hasten corrosion and rusting. The NRC inspectors questioned whether the volume of air in the empty portion of the piping would impair or disable the auxiliary feedwater pumps if they needed to draw water from the lake.

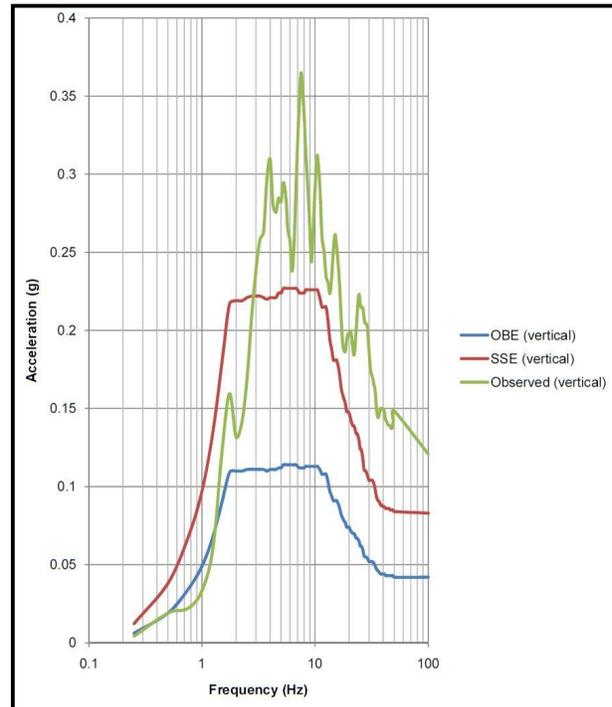
Figure 4. Ground Motion from an Earthquake at the North Anna Plant

The blue line shows the ground motion (in g's), considered in the plant's design, from an operational-basis earthquake (OBE)—one severe enough to prevent the plant from operating. The red line shows ground motion from a safe shutdown earthquake (SSE)—one severe enough to potentially damage the main turbine/generator, but not emergency equipment needed to cool the reactor core. The green line is the actual ground motion measured at the plant during the August 2011 earthquake. The horizontal axis shows how fast the ground is shaking.

At 1:51 pm on August 23, 2011, an earthquake of magnitude 5.8 on the Richter scale, and an epicenter about 12 miles from the site, caused both reactors at North Anna—then running at 100 percent power—to automatically shut down. The earthquake disconnected the plant from its electrical grid, which prompted all four emergency diesel generators to automatically start and supply power to essential safety equipment. Because

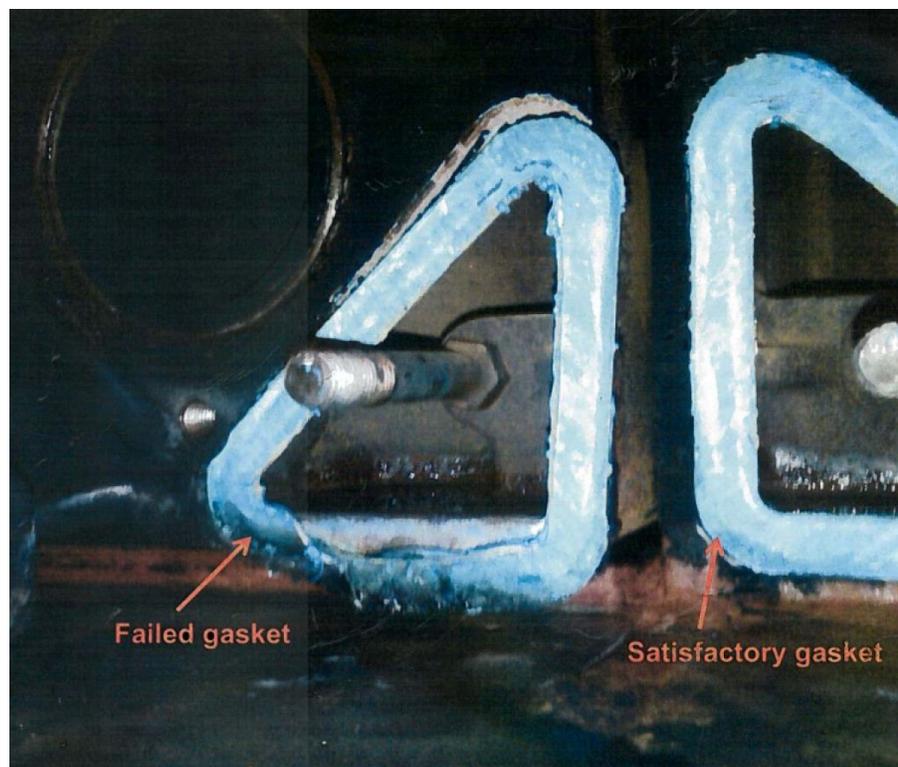
Gaskets on the emergency diesel generators at North Anna.

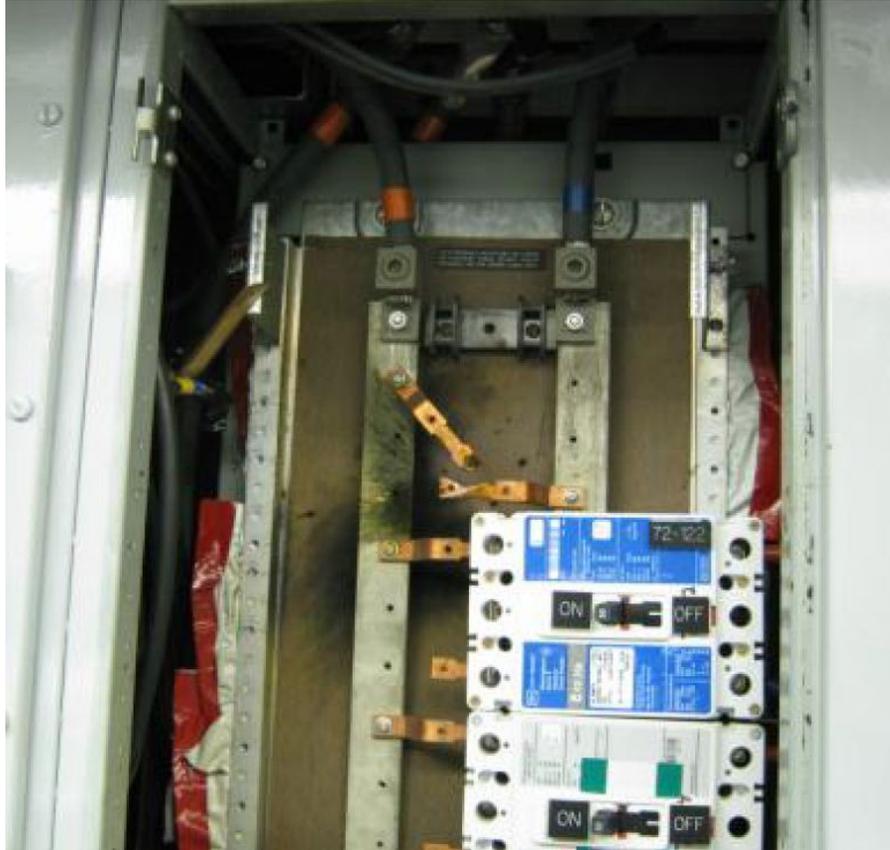
On September 25, a worker loosened a screw inside the distribution panel to gain access to an electrical breaker. A flash from an electrical spark caused the worker to quickly pull away his hands. The right end of a copper bar—which the tightened screw and the worker's hand had held horizontal—fell toward other energized copper bars. The proximity of the bars caused an electrical spark to jump across the gap, and the spark cut power to the area. The electrical short also shut down about half the power supply to instruments and controls in the main control room.

*The distribution panel at Palisades where the disruption in electrical power started.
Source: NRC.*

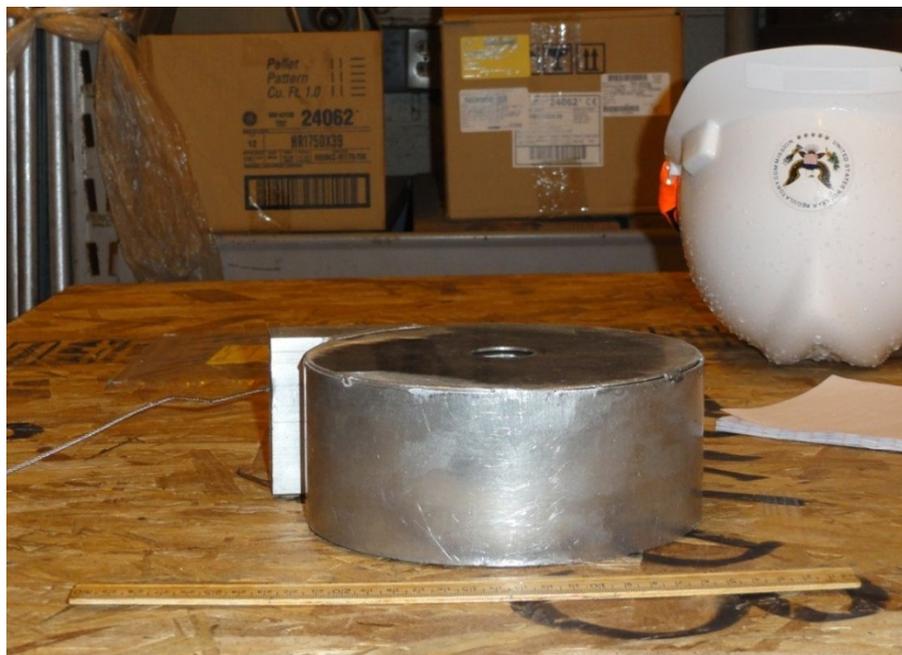
The take-up cartridge could hold only 30 feet of cable and the detector, but the cable for SRM C was 39 feet long. To work around that shortcoming, workers planned to cut the cable, pull the SRM down 9 feet, and cut the cable again. They would then attach the 30-foot cable to the spool in the take-up cartridge, and remotely retract the cable and detector.

The written procedure instructed them to cut the cable “when radiation level rises and/or there is approximately 30’ of cable left” in the tube. However, the cable does not have markings like a measuring tape indicating its length. Instead of pulling the SRM detector 9 feet down, the workers pulled nearly 22 feet of cable from the tube. In doing so, they pulled the highly radioactive SRM detector much closer to themselves than planned. Radiation levels in the area skyrocketed from about 2 rem per hour to more than 1,000 rem per hour. (Instruments in use in the area could not record values above 1,000 rem per hour.)

The SRM cable take-up cartridge at the Perry plant.

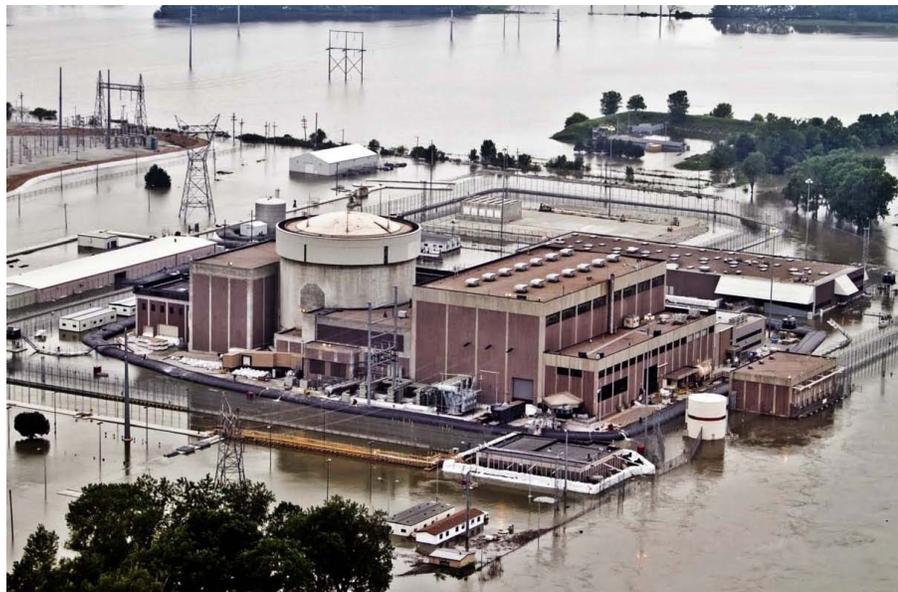
*The Fort Calhoun plant survived severe flooding in June 2011.
Source: Associated Press 06/14/2011*

NRC inspectors discovered that the agency had issued an operating license for Fort Calhoun based on representations by the owner that the facility could withstand flooding up to 1,014 feet above mean sea level. However, NRC inspectors found that flooding above 1,008 feet could disable vital equipment in several structures.

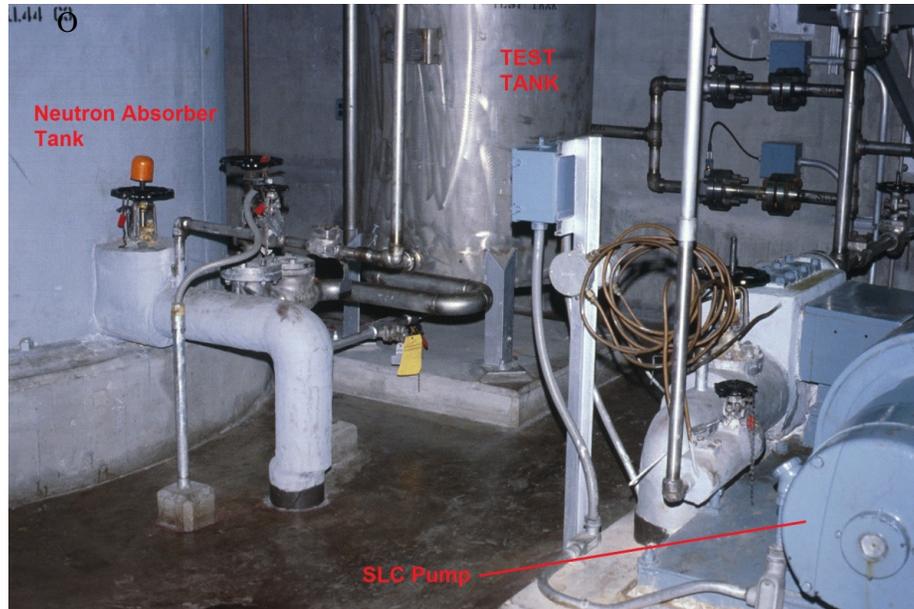
Equipment in the standby liquid control system. Source: NRC

Operators periodically test the SLC system to verify that the pumps and other equipment are ready to function if needed. During this test, to avoid the delay and expense of adding the neutron absorber to water inside the reactor vessel and then filtering it out, the SLC pumps move liquid from the neutron absorber tank to a test tank. This procedure determines whether the pumps and control switches work, and whether liquid can be readily transferred out of the neutron absorber tank. One of the last steps in the test procedure is to pump the liquid from the test tank back into the tank storing the neutron absorber.
