**UNITED STATES
NUCLEAR REGULATORY COMMISSION
REGION I**
2100 RENAISSANCE BOULEVARD, SUITE 100
KING OF PRUSSIA, PENNSYLVANIA 19406-2713

**SUBJECT: SUSQUEHANNA STEAM ELECTRIC STATION – NRC INTEGRATED
INSPECTION REPORT 05000387/2012003 AND 05000388/2012003**

Enclosures: Inspection Report 05000387/2012003 and 05000388/2012003
w/Attachment: Supplemental Information

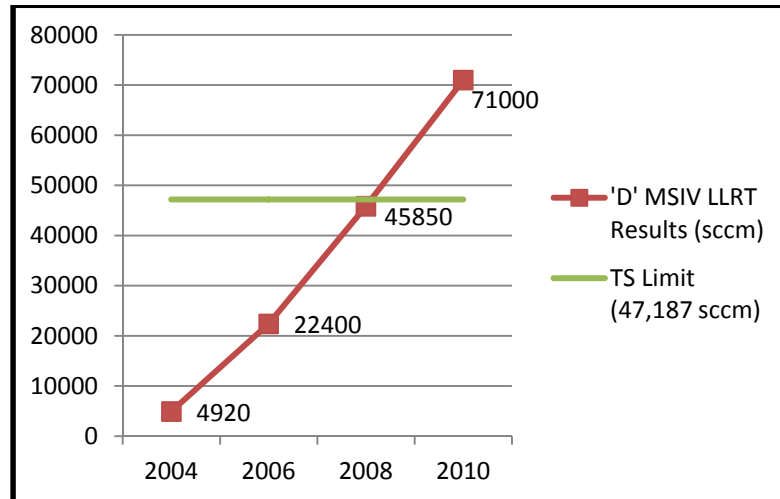
A Level 2 ACE (CR 1554813) was performed to evaluate the LLRT failure and determined that excessive leakage of the ‘D’ outboard MSIV was “due to inadequate maintenance of the MSIV seating surfaces” performed in 2010. Specifically, as discussed in NCV 05000387/2012003-002 above, the ACE identified that the maintenance instructions, MT-083-011, “MSIV Disassembly, Inspection and Reassembly (Longnose Poppet),” were inadequate and resulted in improper boring bar set up and machining of the seating surfaces. This maintenance directly led to the excessive leakage observed on April 8, 2012.

During additional reviews of valve performance, the inspectors identified that this was the second consecutive outage that HV141F028D had failed its as-found LLRT. Specifically, in 2010, the as-found LLRT would not pressurize. A Level 3 ACE (CR 1242099) determined the cause of that LLRT failure was failure to perform maintenance on the valve in the previous outage (2008) due to an adverse trend in leakage. Despite the 2008 as-found LLRT leakage value being ~97 percent of the TS limit and the trend showing strong evidence that the subsequent LLRT would exceed the TS limit, no valve maintenance was performed to restore margin.
