November 13, 2014

**SUBJECT: THREE MILE ISLAND STATION, UNIT 1 – NRC INTEGRATED  
INSPECTION REPORT 05000289/2014004**

Enclosure: Inspection Report 05000289/2014004  
w/Attachment: Supplemental Information

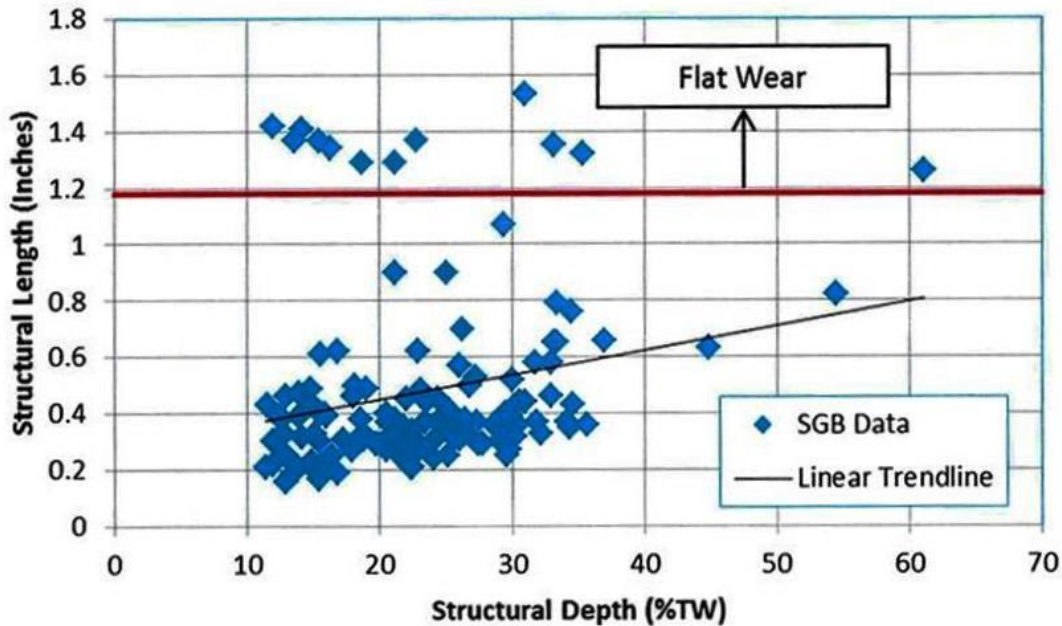
**Figure 1: All Profile Results for SGB**

**As shown in Figure 1**, there is some correlation between structural length and structural depth. However, as previously mentioned, this correlation is primarily driven by the shallow, tapered indications. When a tapered flaw first initiates, it will only be present at one edge of the support and may only have a total length of 0.4", for example. Obviously, if the total length is 0.4" and the flaw is tapered, its structural length will be less than 0.4". As the flaw grows in depth, its total length and structural length will increase provided the taper angle remains the same. This is the primary reason that there is an apparent relationship between structural length and depth.

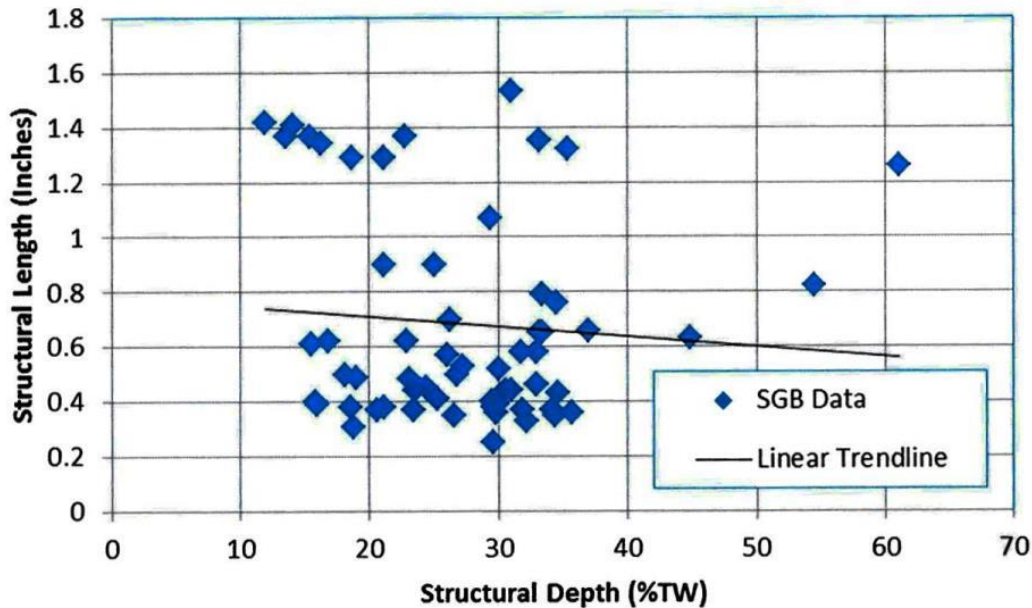
**Figure 2: Profile Results for Indications Greater Than 1 Inch Total Length**

In order to illustrate the effect that the shallow tapered indications have on this correlation, another curve was generated which includes only those profiled indications with total measured lengths greater than 1 inch. Applying this criterion effectively eliminates the shallow tapered indications since tapered flaws would need to grow to a relatively deep depth before they would reach a length of 1 inch. This relationship is shown in **Figure 2** as shown in the figure; there is no correlation of increasing structural length with increasing structural depth. Hence, for the flaws of most concern (flat or tapered and relatively deep), there is no correlation between structural length and structural depth.
