The 2011 off the Pacific coast of Tohoku Pacific Earthquake and the seismic damage to the NPPs

4th April, 2011

Nuclear and Industrial Safety Agency (NISA)
Japan Nuclear Energy Safety Organization (JNES)

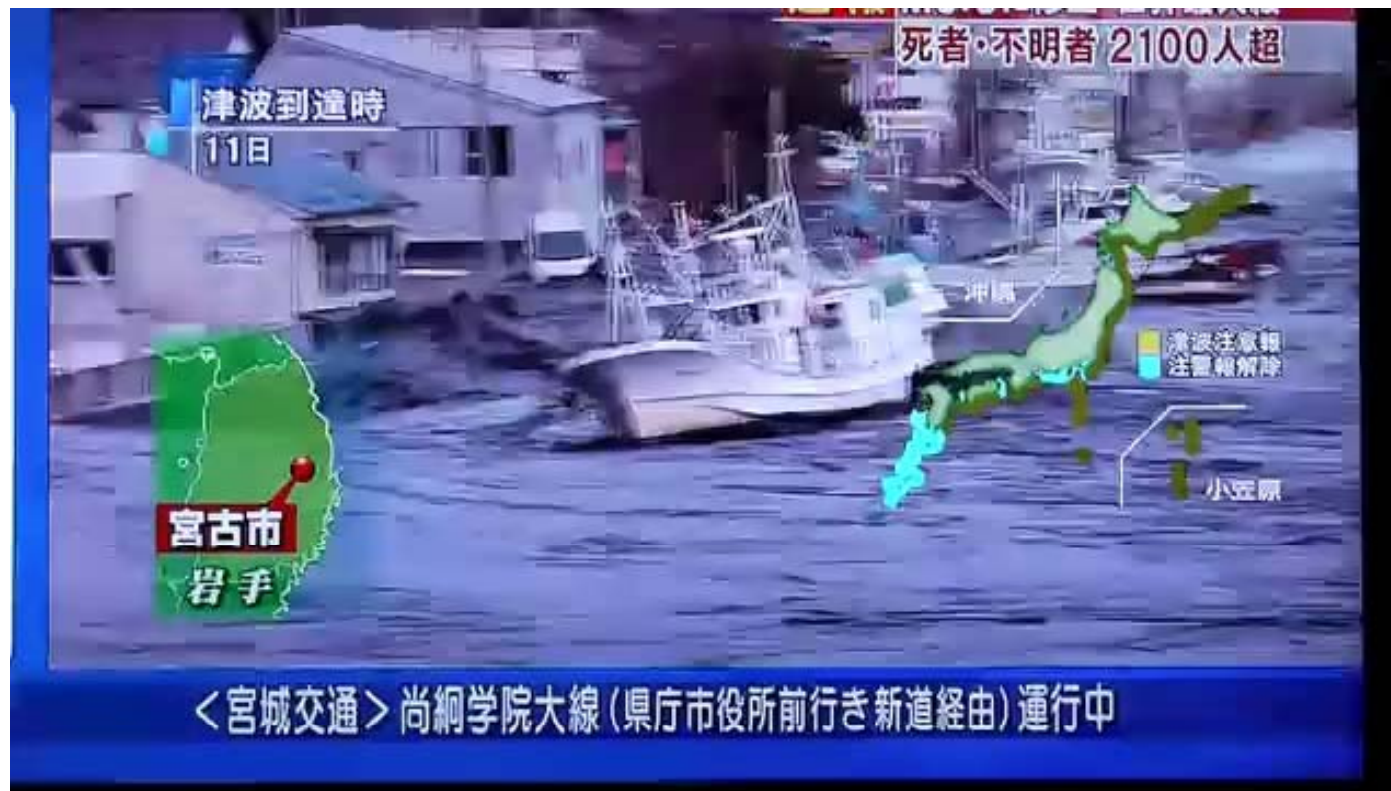
1-2. Tsunami after the earthquake

- East coast of northern area in the main island of Japan is seriously damaged
- As of April 4, 12,175 people are dead and 15,489 people are missing

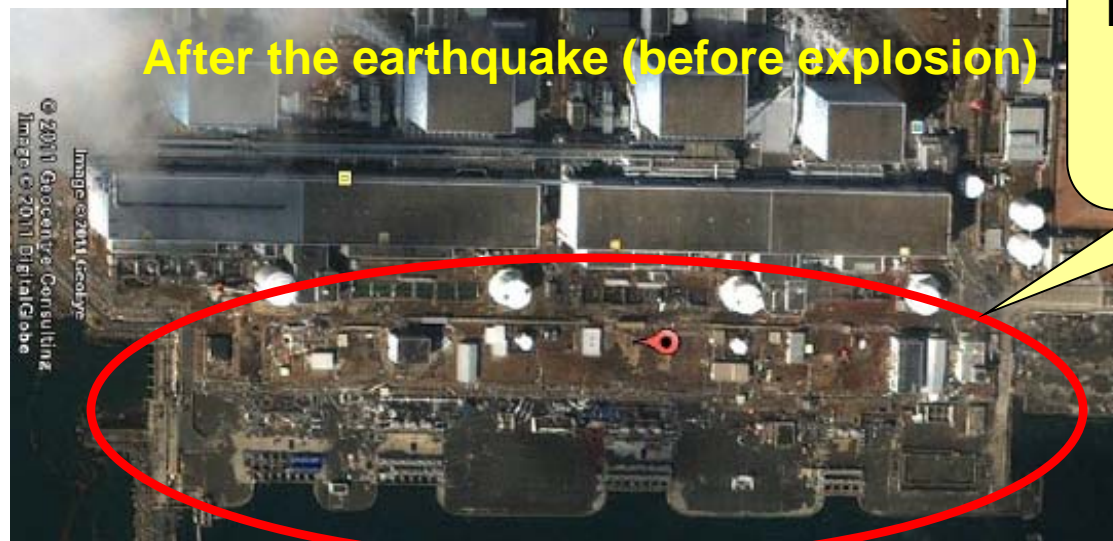
3-1. Satellite view of Fukushima Dai-ichi NPP

Many structures facing the bay are destroyed

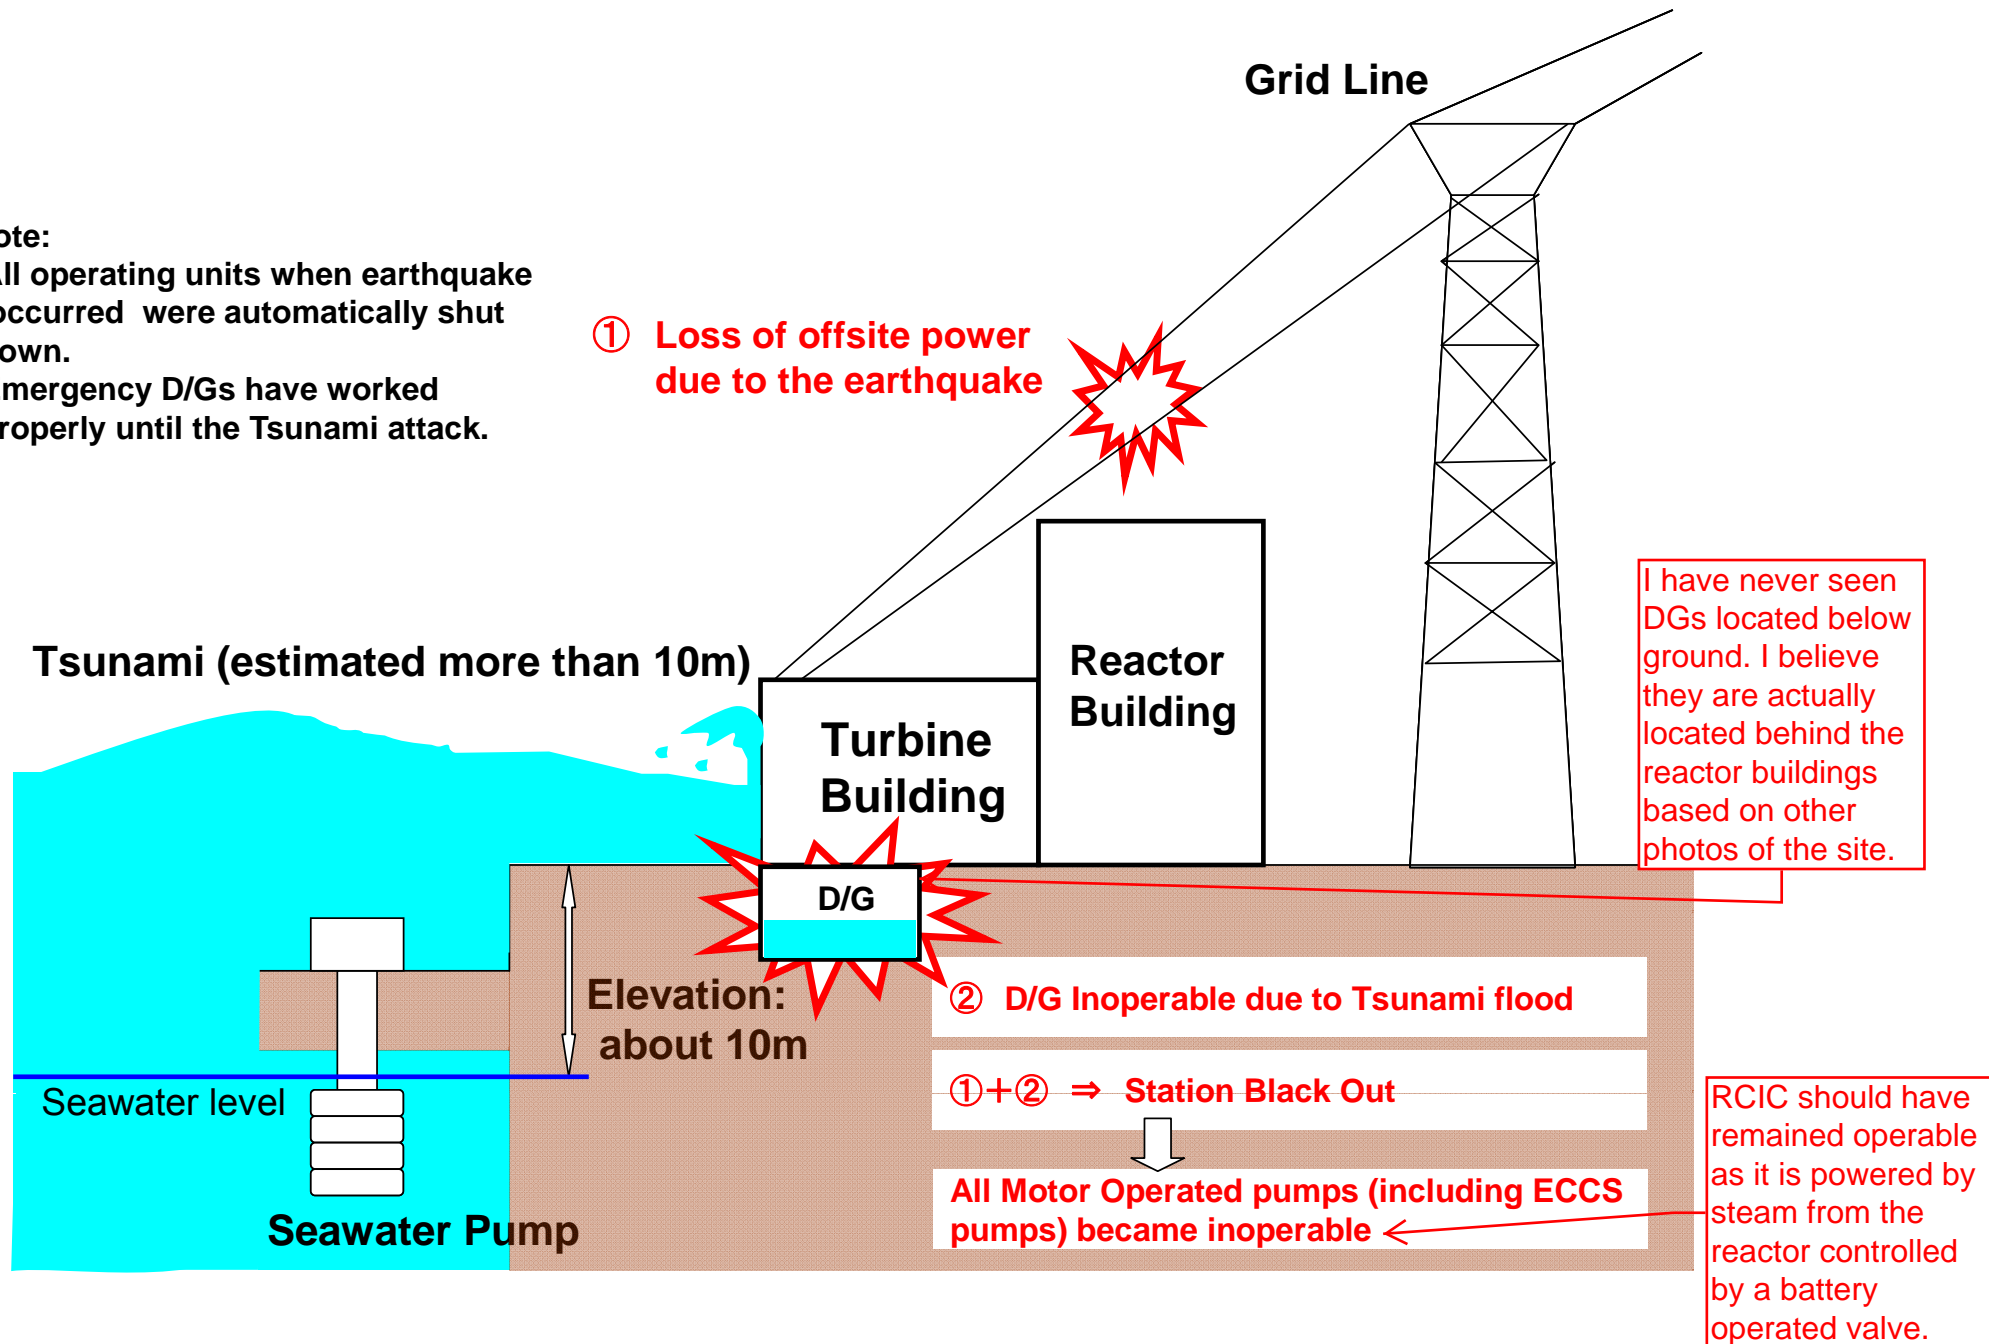
3-2. Major root cause of the damage

- All operating units when earthquake occurred were automatically shut down.
- Emergency D/Gs have worked properly until the Tsunami attack.

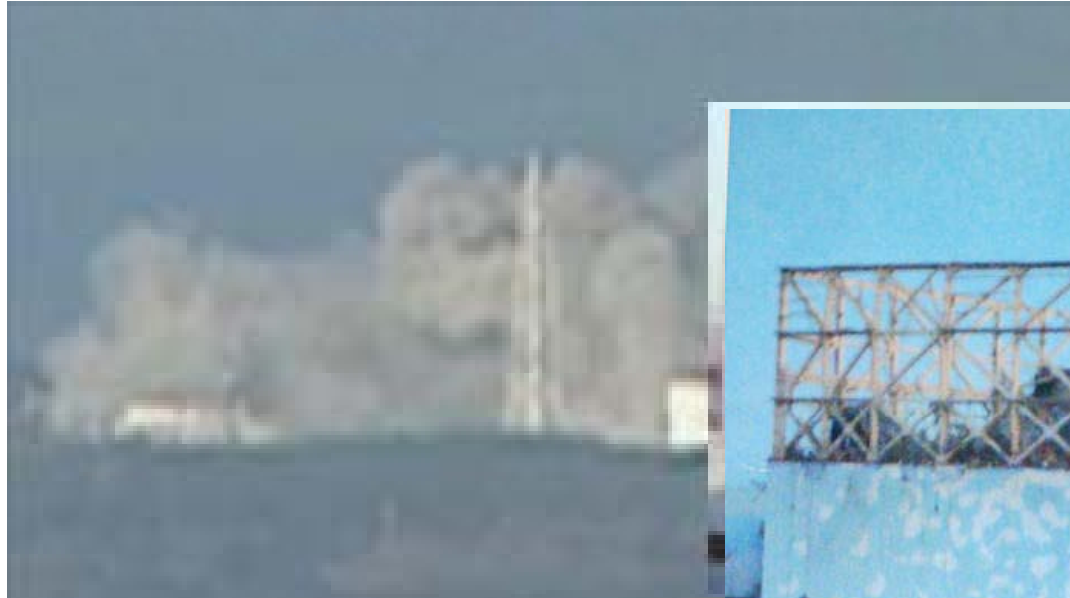
3-7. Major event progression at Unit 1 (3/4)

Hydrogen explosion in the operation floor

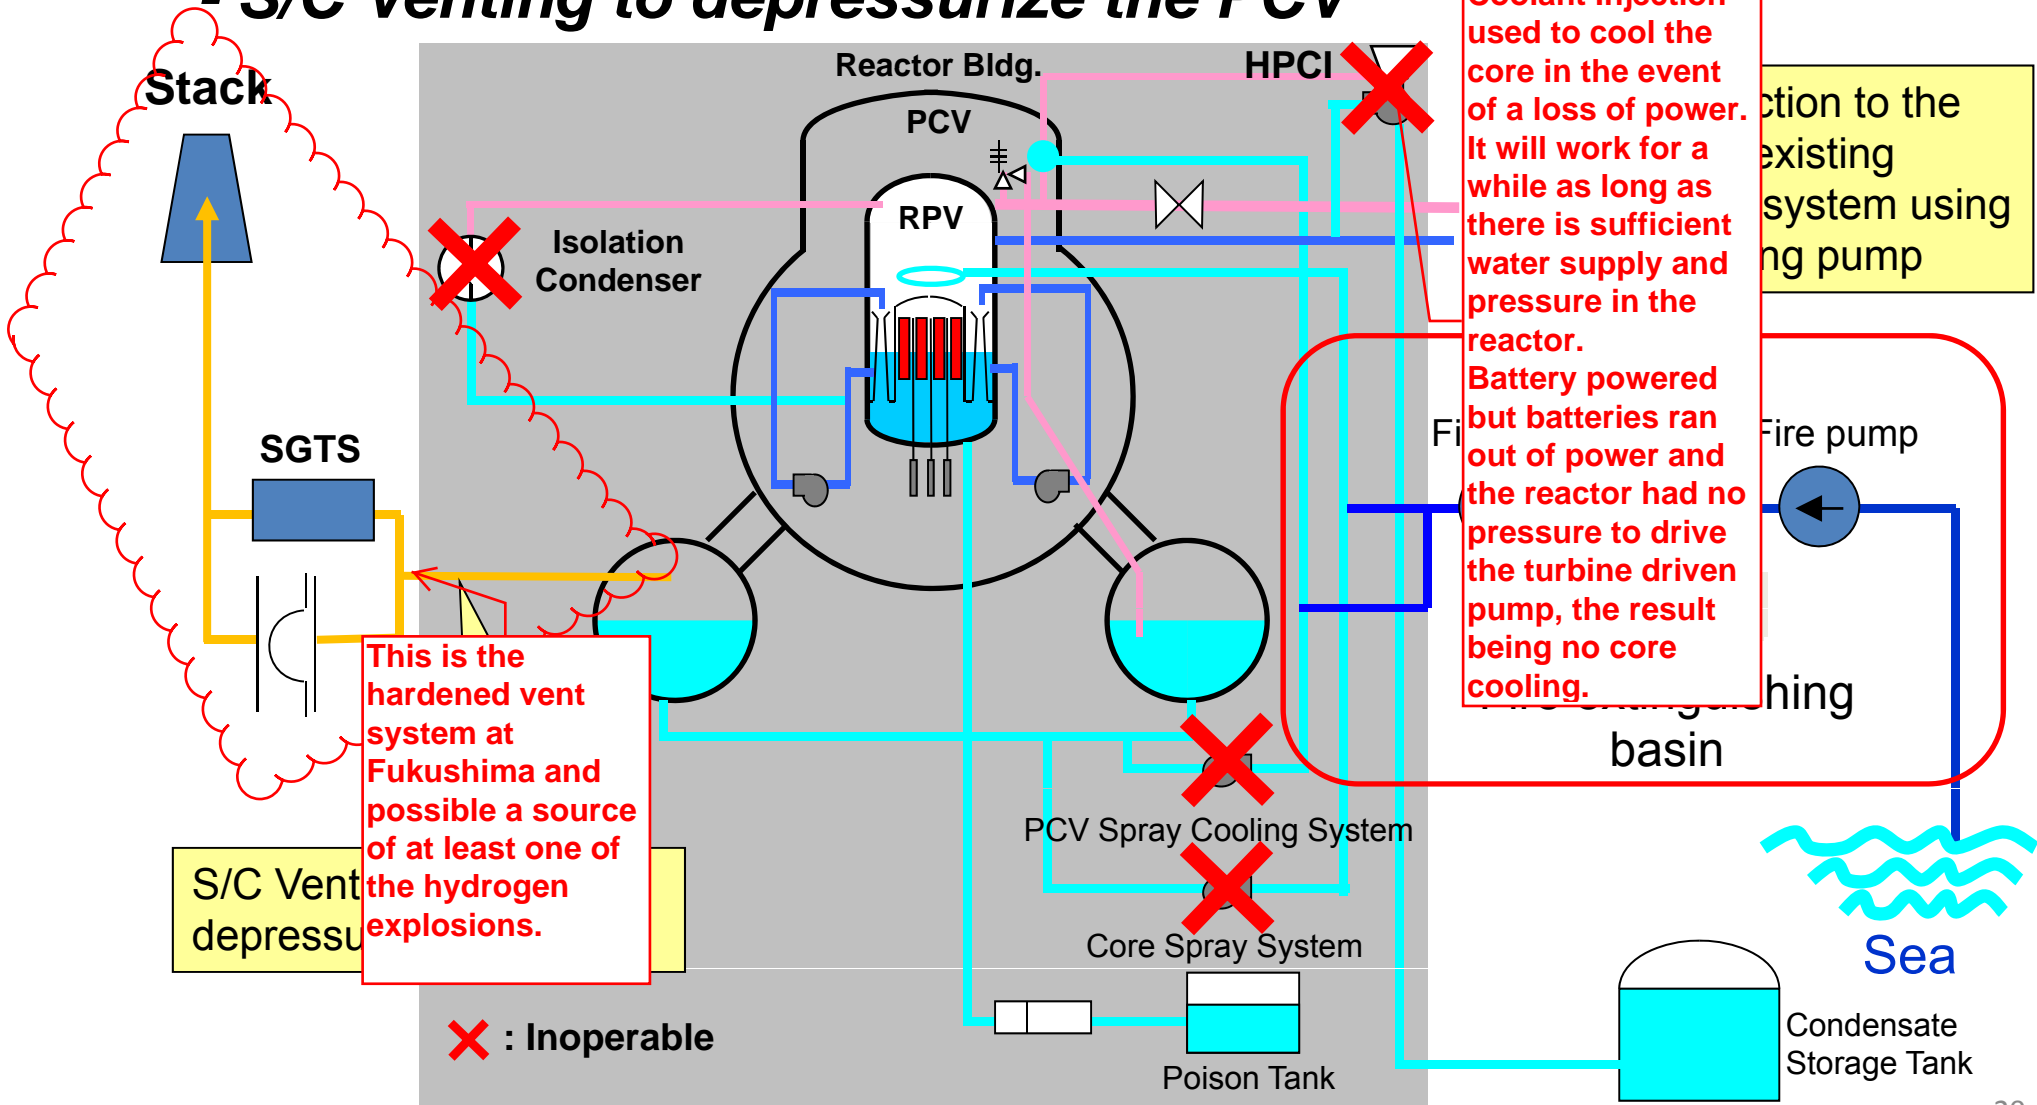
3-7. Major event progression at Unit 1 (4/4)

- Sea water injection using fire water pump
- S/C Venting to depressurize the PCV

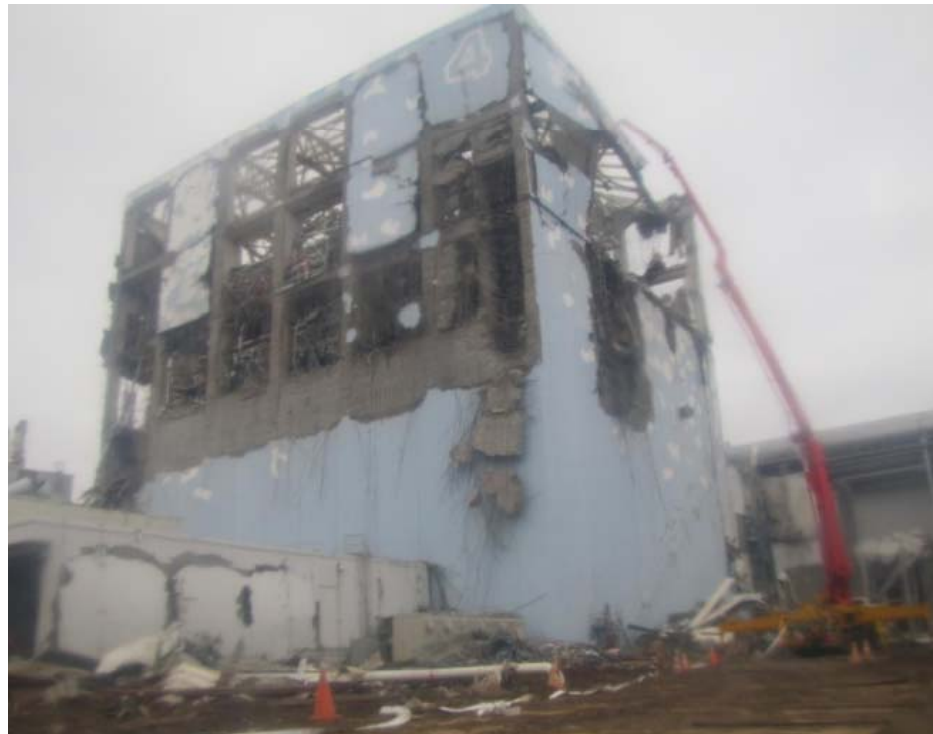
Photo: Water spray into the SFP in Unit 4 using concrete pump truck

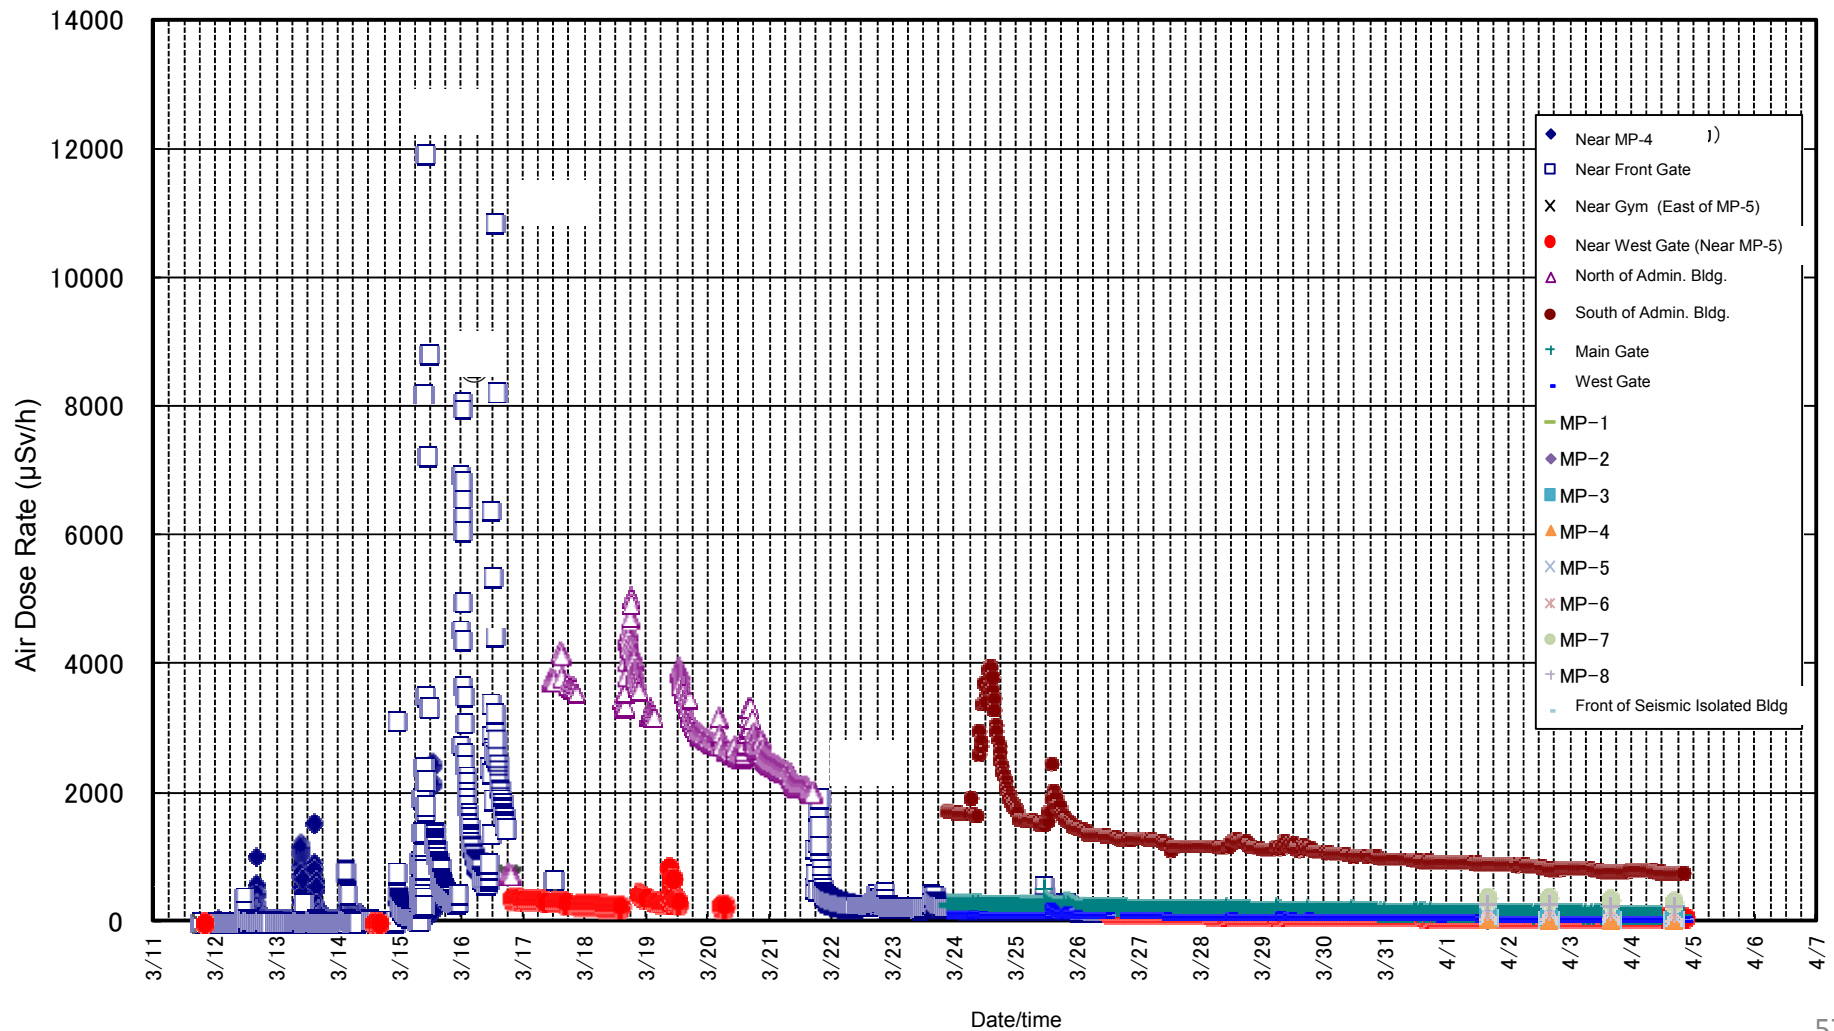
1F Monitoring Trend

○Registered 11930 μ Sv/h around Front Gate on March 15.
