The NRC and Nuclear Power Plant Safety in 2011

LIVING ON BORROWED TIME

DAVID LOCHBAUM

March 2012

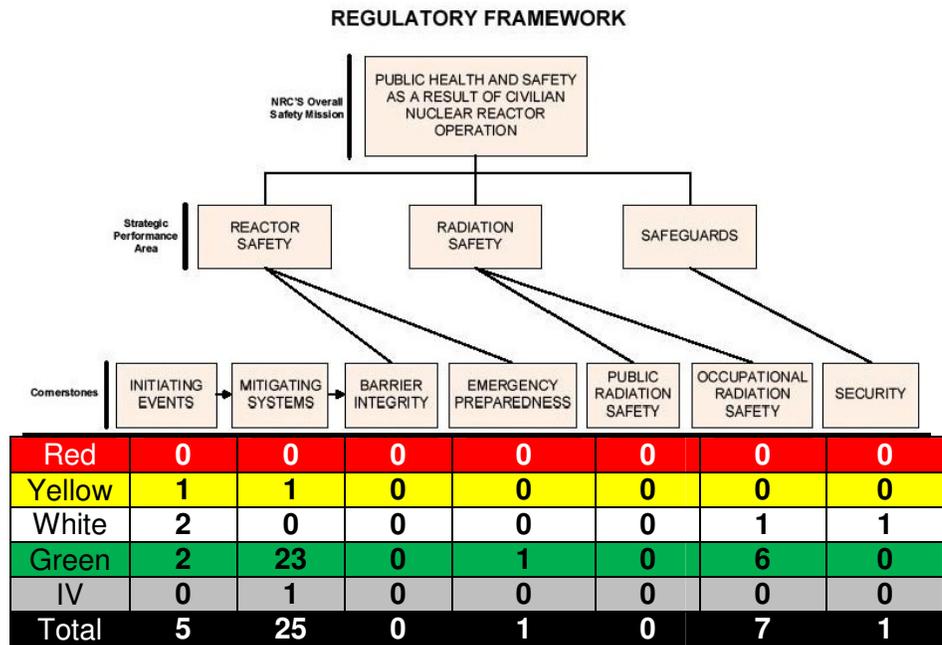
Figure 1: Near-Misses in 2011 by Cornerstones of the Reactor Oversight Process

In 2011, reports from the SITs and AIT dispatched by the NRC identified 39 violations of NRC safety regulations. Figure 1 classifies these violations by the seven cornerstones of the reactor oversight process (ROP).²

The NRC special investigative teams did not classify any safety violations as Red—the most serious—in 2011. The teams did classify two safety violations as Yellow. One occurred at the Oconee plant in South Carolina, while the other occurred at the Palisades plant in Michigan.

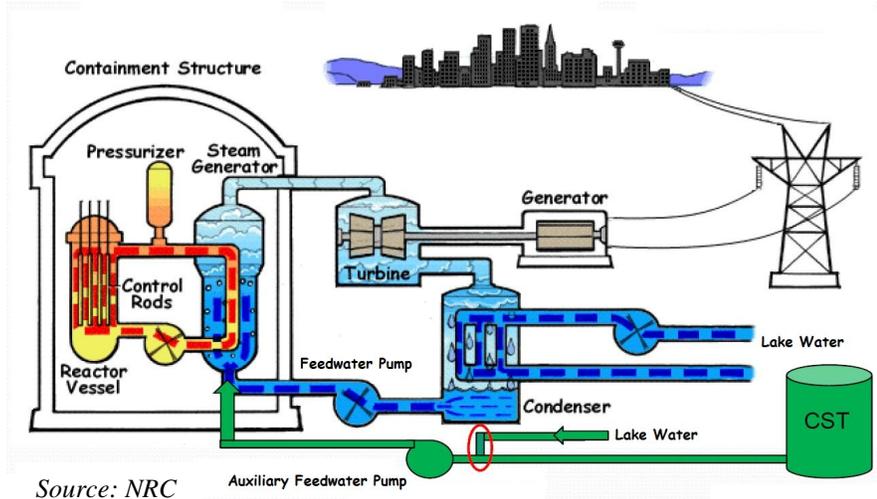
Figure 2. Outline of a Pressurized Water Reactor Such as Byron and Braidwood

On January 31, 2011, NRC inspectors at Byron questioned the longstanding practice of maintaining portions of piping for the essential service water supply to auxiliary feedwater pumps empty of water. The NRC raised the same issue at the Braidwood plant because it had a similar design and operating procedures (Figure 2).

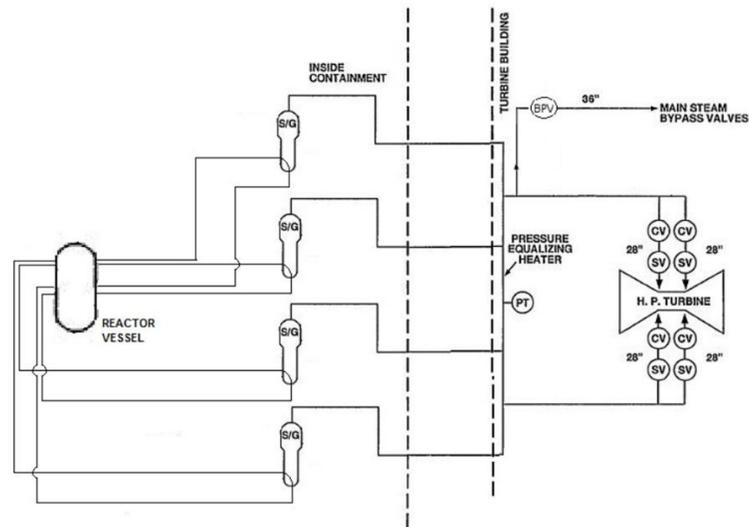
Figure 3. Schematic of a Typical Main Steam System for a Pressurized Water Reactor

The turbine control valves (labeled CV in Figure 3) regulate the flow from the steam generators into the high pressure turbine (labeled HP turbine), to maintain constant pressure at that point. The test involved closing each of the four control valves one at a time. When a valve is closed, operators manipulate switches to open the other three valves slightly to compensate.

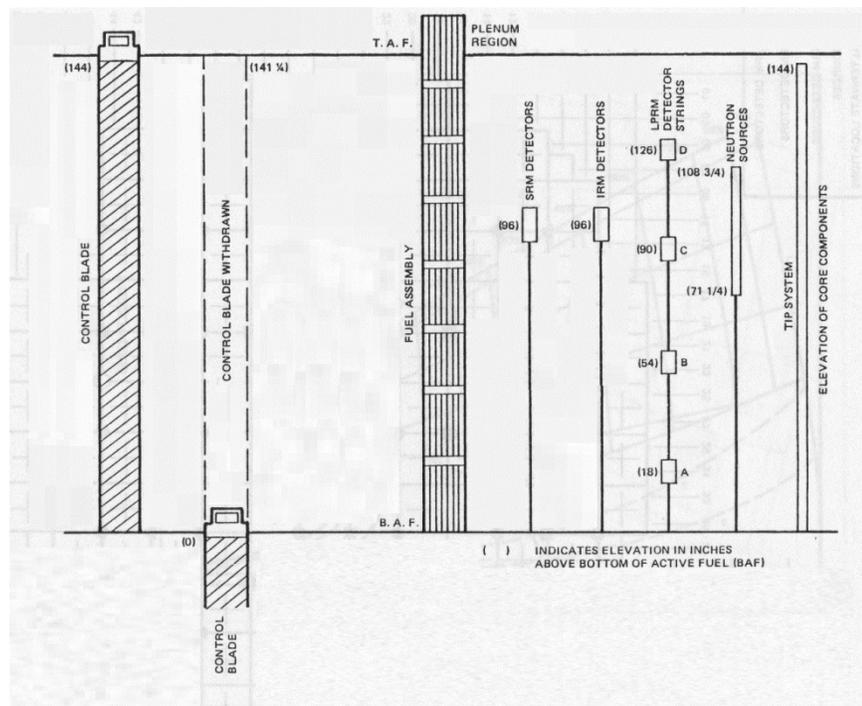
Figure 5. Side View of a Boiling Water Reactor Core Showing the Positions of Its Components

Workers had replaced SRM detector C in February 2009. SRMs are replaced periodically when their sensitivities decrease because the uranium they contain depletes, or because of wear and tear on their cables. During a reactor startup in May 2010, operators were unable to retract SRM C from the reactor core, and it was quickly disabled as it remained in the core during high-power operation. Workers were scheduled to replace SRM C during the refueling outage in 2011.

The workers entering the area beneath the reactor vessel on April 22, had instructions to cut the cable for SRM C, and attach the cut end to a spool in a portable take-up cartridge. After connecting the cable to the spool, workers planned to exit the area and remotely turn the spool to wind the cable and SRM C into the cartridge. They would then place the cartridge in a lead cask for shielding against high levels of radiation from the unit. The plant owner calculated that the radiation level one inch from the SRM detector was 66

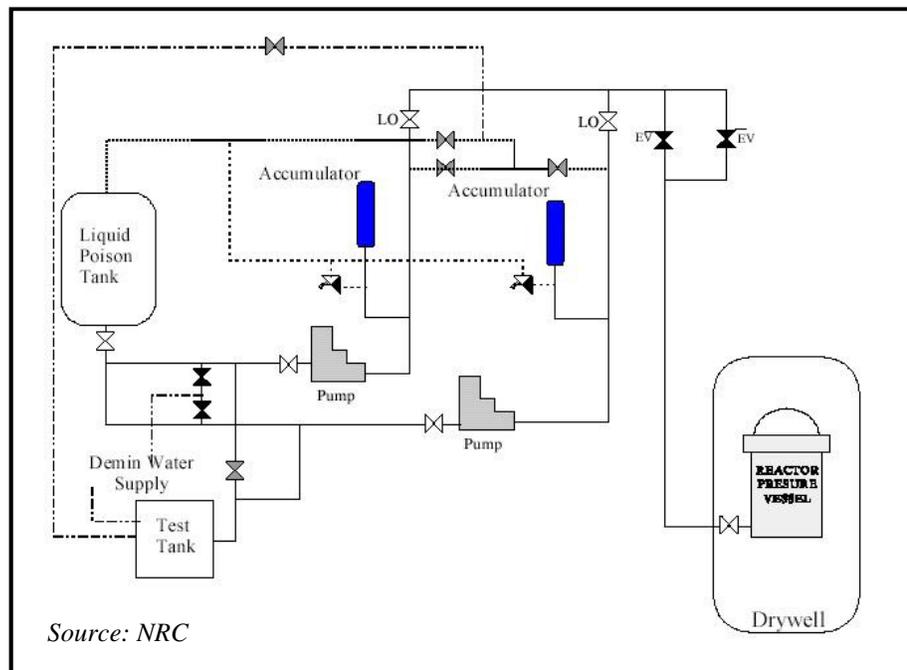
Figure 6. Schematic of the Standby Liquid Control System

The standby liquid control (SLC) system backs up the control rod drive system (Figure 6). The SLC system can inject neutron absorbers in liquid form into the metal vessel housing the reactor core. The SLC system takes minutes to achieve what the control rod drive system can achieve in seconds. However, the SLC system can shut down the reactor from full power and keep it shut down, even if the control rod drive system experiences a total failure.

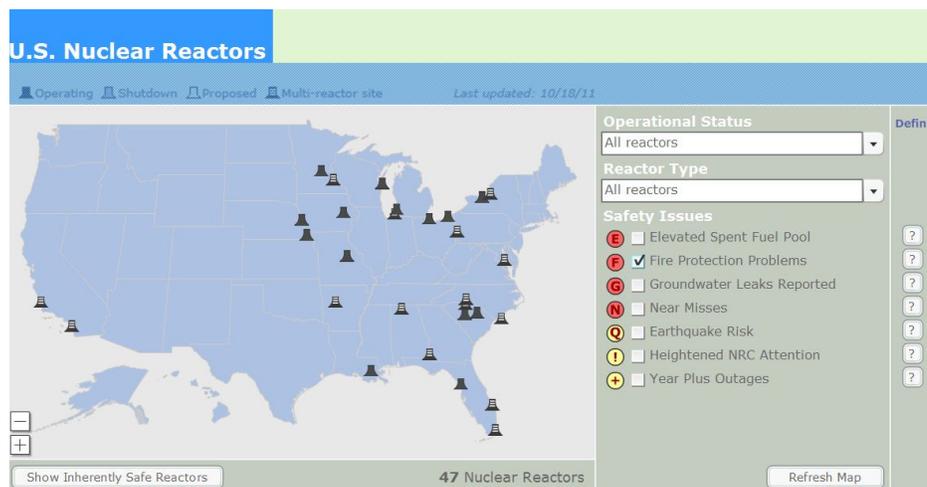
Figure 7. Operating Reactors with Known Fire Protection Problems

A few years ago, UCS added a feature to its website called the Nuclear Power Information Tracker.⁶ The tracker allows users to identify U.S. nuclear reactors that the NRC knows do not fulfill safety criteria. For example, one of the criteria is compliance with fire protection regulations. According to the tracker, 47 of 104 operating U.S. reactors do not meet this standard (Figure 7).

Three of these reactors are at the Browns Ferry nuclear plant in Alabama. This is ironic, as the NRC adopted fire protection regulations in 1980 in response to a March 1975 fire at Browns Ferry that disabled all emergency core cooling systems for the Unit 1 reactor, and most of those for Unit 2. In ensuing inspections around the country, the NRC found that many reactors failed to meet these regulations, which led the agency to adopt an alternative set in 2004. Owners then had the choice of complying with either the 1980 or the 2004 regulations.

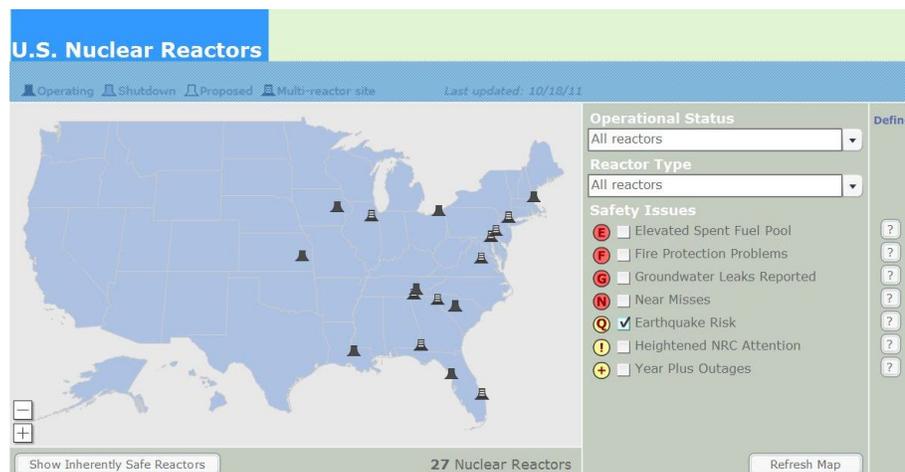
Figure 8. Operating Reactors with Known Seismic Protection Problems

Speaking of shaky ground, the NRC also knows that 27 reactors are operating with seismic protection levels below seismic hazard levels (Figure 8).

In 1996, the NRC revised its regulations governing seismic hazards in central and eastern United States. The NRC based this revision on information from the U.S. Geological Survey that the frequency and magnitude of earthquakes in these regions were greater than previously understood. The 1996 regulations required applicants seeking to build and operate new reactors to design protection levels for the heightened seismic hazards.
